# Decision Grade Audit Report

Town of Washington, NH

Police Station

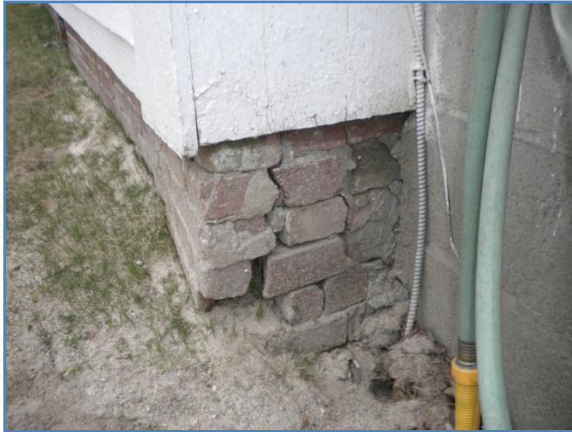
The original section of this building sits on a brick foundation. About two feet of this foundation is above grade. Figure 2 shows one particularly deteriorated section of the foundation. There are numerous vertical cracks through the brick which illustrate how the foundation has settled, or sunk, over the many years this building has been standing.

- A proper evaluation of the foundation by a mason or foundation specialist should be done. This building has been standing for a relatively long time. If it is to stand the test of many more years of service to the town, corrective measures, or possible replacements, are recommended.
- Insulate the underside of the first floor. This should be done with closed cell spray foam. The foam insulation will not only offer superior R-Value, but will air seal at the same time.
- Put down a vapor barrier over the dirt floor of the crawl space. Though the space seems to stay fairly dry, it would be beneficial to take steps to further protect the structure.

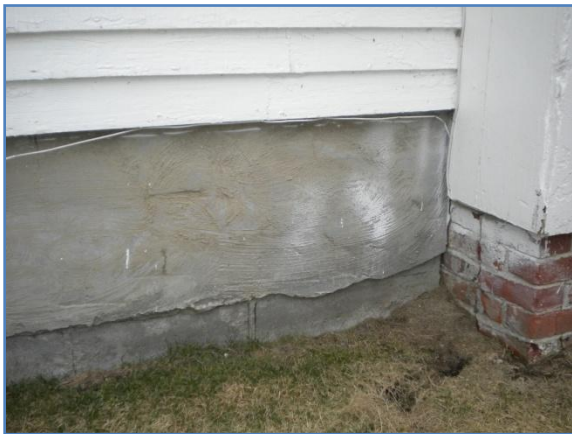
The addition on the back side of the building sits on a concrete block foundation. Some areas of this foundation have cracked blocks, and the mortar has separated between some of the blocks. See Figure 1. Figure 4 shows how one side of this foundation was coated with a type of cement mix. This was likely done to sturdy the foundation as this side probably started failing first.

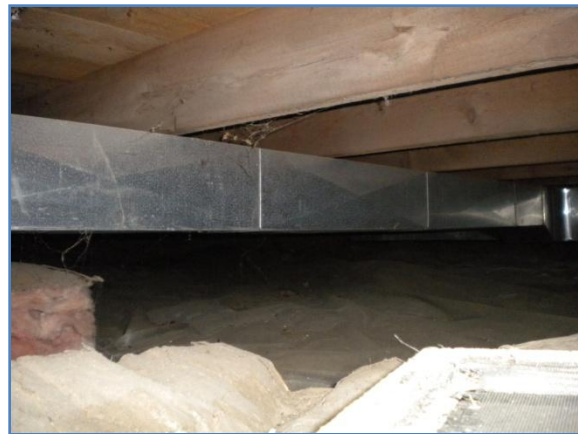
There is about two feet of space under the building before the dirt floor. The floor joists and decking boards appeared to be in great condition on the areas we were able to inspect. See Figure 3. This suggests that the space stays relatively dry, which is the goal for any basement or crawl space. There was no insulation found between this space and the first floor. This is a large inefficiency for a couple of reasons: first, that the heat of the first floor is conducting through the flooring material and lost to the cold dirt floor and foundation walls; second, the large amount of air infiltration from the crawl space to the conditioned space above contributing to the “stack effect” of this building. See an explanation of the stack effect below.

Figure 3 also reveals the unsealed and uninsulated duct work. This is a great inefficiency, and will be discussed more in the Mechanical section of this report.

- Air seal and insulate all of the supply ductwork. Sealing the ducts could be done with a metalized tape, though the use of mastic is preferred. It is not necessary to insulate these ducts to the degree as if they were running outside of the thermal boundary; a foil faced bubble wrap taped at the seams will suffice.

- Air seal and insulate the return ductwork in the crawl space. The preferred material for air sealing here is mastic. The insulation should be a minimum of R-8(installed) foil faced fiberglass duct insulation.

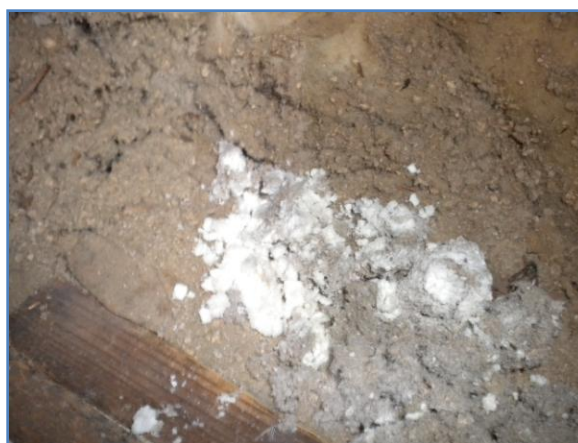
Figure 5

The exterior walls of the original building have wood clapboard siding, 1 inch sheathing boards, true 2x4 inch studs, and a lath and plaster interior finish. All of the wall cavities which we examined we found to be partially filled with a cream colored light weight powder. See Figure 5. After spending some time investigating as to what the substance may be, our best guess is that it is either Urea Formaldehyde foam insulation (UFFI) that has broken down over many years, or it is some type of insecticide.

- Have the powder from in the exterior walls tested to confirm whether or not it is UFFI, or if it should be treated as a toxic material. If it is UFFI, we recommend removing the powder. This could likely be done with a high powered vacuum.
- After the wall cavities have been cleared, have an insulation contractor fill the empty cavities with cellulose insulation. The new insulation will not only add effective R-Value to the walls, but also aid in reducing convective air currents.
- If the powder is found not to be UFFI, and contains asbestos or other toxic substances, we recommend contacting NHDES for a list of NH companies who are certified to remediate the substance. After this has been done, refer to the above recommendation.

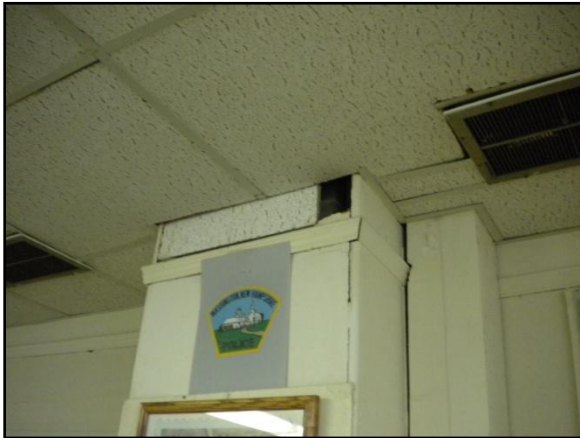
Figure 6

There is a suspended ceiling above the first floor office which hides the original lath and plaster ceiling. There is about 2 feet of space above the suspended ceiling. The forced hot air heating system has two zones, one for the first floor (zone 1) and one for the second (zone 2). The first floor is the primary occupied space, and is maintained to higher temperatures than the second. For this reason, it is very important to air seal between the two floors. There are some minor penetrations for wiring and plumbing, with the major air passageway being around the unused chimney. Figures 6 and 7 exemplify just how easily conditioned air can pass from the first floor to the second, while Figures 8 and 9 reveal how this problem continues on the second floor, as the chimney is open from the second floor to the attic space.

- Repair the drywall of the mechanical room ceiling. Also, make sure that the access panel to the space above is sealed when not in use.
- Air seal the gaps around the chimney to stop air movement from the first floor to the second.
- Air seal any other penetrations that would allow for air movement from the first floor to the second.
- Apply weather stripping to the first floor door that leads to the stair well.
- Repair any damages to the second floor lath and plaster ceiling. This would include sealing any cracks where the plaster is cracked.
- Seal around the chimney so that air movement cannot occur from the second floor space to the attic.
- Seal any other penetrations from the second floor to the attic.
- We recommend achieving an R-60 in the attic. This can be done by adding loose fill cellulose insulation.

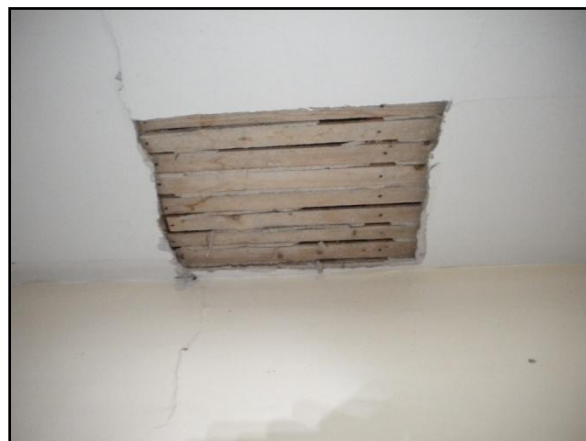
Figure 10

The second floor ceilings also provide for ample upward movement of air. There are some minor penetrations through the lath and plaster ceiling from lighting, ceiling fans, smoke detectors, etc. However there are currently several major paths from the conditioned space to the attic: the exposed chimney from Figure 8, the exposed lath in Figure 10, and the two access points to the attic space.

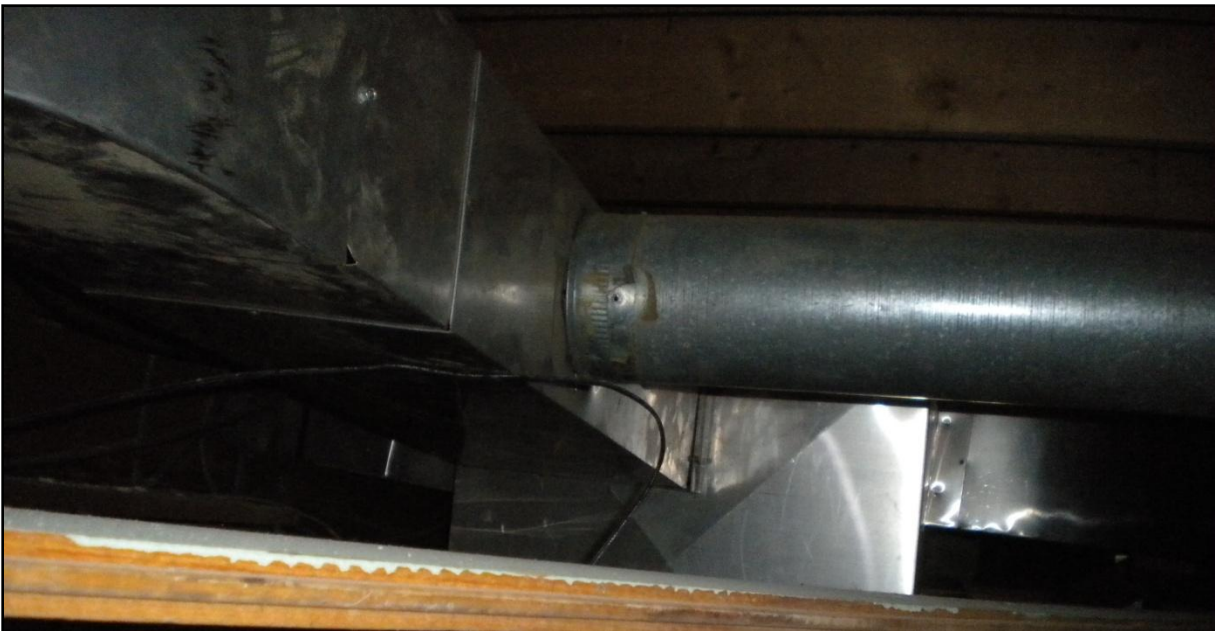
Figure 12

The supply plenum runs from the top of the furnace and feeds the two zones (1<sup>st</sup> and 2<sup>nd</sup> floor). All of the supply ducts run from a three foot tall mechanical space in the addition that separates the first and second floor. See Figure 12. From here, there are two main supply ducts that feed two registers located in the first floor ceiling. The remaining supply ductwork runs to the second floor. Though all of the supply ductwork runs within the thermal boundary, none of this ductwork has been air sealed or insulated. The purpose of a heating system's "distribution" component is to transport heat to where the heat is intended to go. Greater comfort and savings would be realized from air sealing and insulating these ducts.

- Continue the PVC supply air pipe and connect to the furnace. Doing this should allow for the mechanical room to be air sealed.
- Seal off the open chimney thimble in the mechanical room.
