# ENERGY AUDIT REPORT

**Washington Elementary School**

**337 Millen Pond Road  
Washington, New Hampshire**

**December 2011**

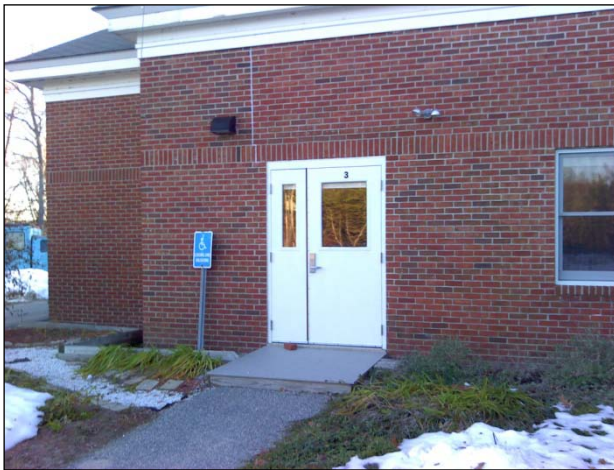
The building is slab on grade and constructed with cement block walls with 2" of rigid foam insulation sandwiched between the block and exterior brick surface. The school has twelve (12) insulated exterior doors that have door seal gaskets in various levels of disrepair. See Figures 2 and 3 for an example of the current state of door seals at the school.

**Figure 2: Typical connection between top of exterior wall and attic at eaves end of building**

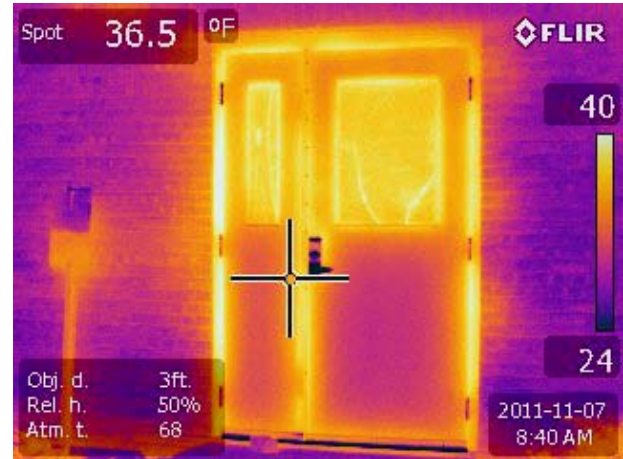
**Figure 3: Typical connection between top of exterior wall and attic at eaves end of building**

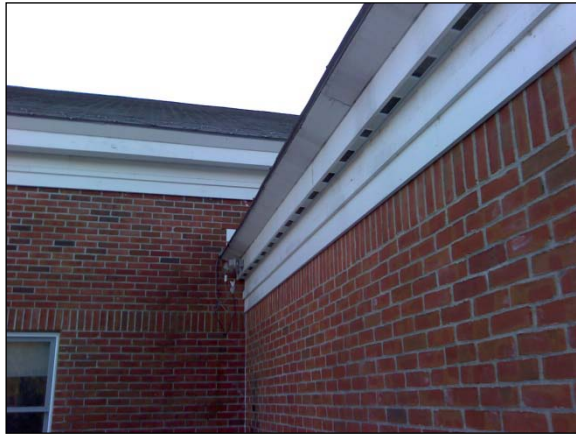
During the site visit it was noted approximately 300 feet of electric snow melt cabling was installed along the majority of the roof edge along the North side of the school. The school custodian stated the electric snow melt system is needed to combat the ice dams that form along the eave edge on the front (north side) of the school. It was noted ice dams also form along the back (south side) of the school but an electric snow melting system is not installed to combat the ice dams on the back of the school. See Figures 4 and 5 below for a picture and IR image of the exterior walls of the multipurpose room and the kitchen (to the right). As you can see there appears to be heat loss along the eaves. Investigation of the exterior wall from inside the kitchen found a noticeable air movement above the ceiling tiles and near the exterior wall.

**Figure 4: Multipurpose Room and Kitchen wall**

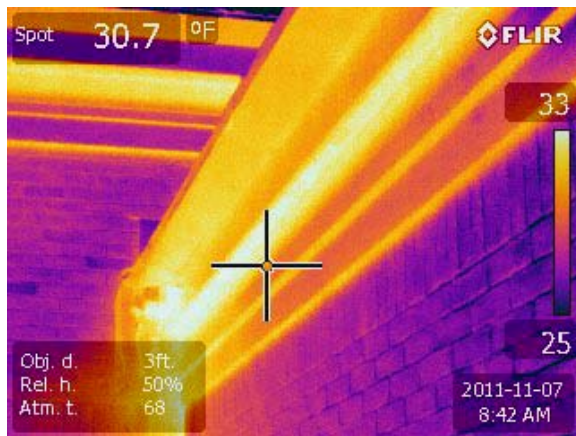
**Figure 5: IR image of Multipurpose Room and Kitchen exterior wall**

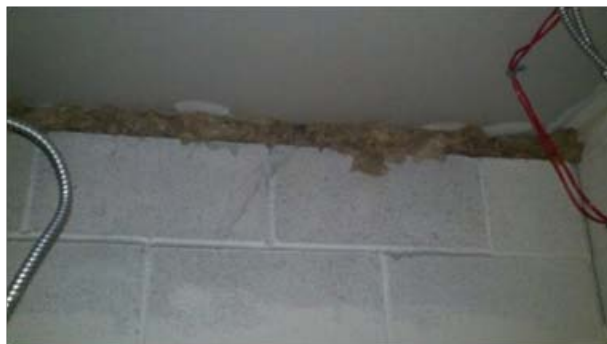
Figure 6 below is a picture of the typical connection between the top of the exterior wall and the attic at the eaves edge. It is believed there is a lack of adequate air sealing between the top of the exterior wall and the attic at the eaves is the cause of the ice dams forming.

**Figure 6: Typical connection between top of exterior wall and attic at eaves end of building**

Based on conversation with the Washington Elementary School on the ice dam problems, review of the original construction documents and the IR images GDS concludes it is critical that a proper air barrier is added to mitigate the ice dam problem on the eaves end. GDS was only able to investigate a small portion of the wall to attic roof connection. GDS recommends performing further investigation of the air sealing issue to assure the proper air sealing solution is applied.

Based on previous air sealing projects GDS recommends adding a minimum of 2" of

closed cell spray foam along the entire top of wall to attic connection to provide the lacking air sealing. Based on previous air sealing projects that had pre and post air sealing blower door testing performed GDS conservatively estimates the infiltration rate can be reduced by 150 CFM by air sealing the approximately 300 feet of top of wall to attic connection. Based on recent contractor pricing on similar projects GDS estimates the cost to perform the air sealing at \$20 per linear foot. Although it will be an additional cost GDS strongly recommends including blower door test pre and post air sealing to accurately estimate the expected savings from this air sealing project.

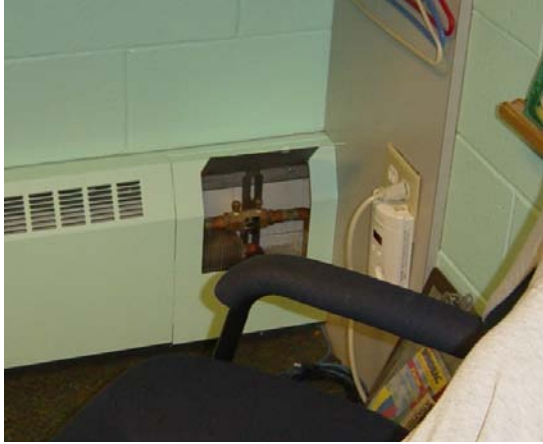
During the site visit it was noted that Class Rooms 1, 2 and 3 experience overheating. These classrooms are in the original part of the school and are heated by fin tube radiation installed along the original exterior walls and controlled by wall mounted thermostats that are intended to open the hot water control valves when there is a call for heat and close the valves when space temperature set point is met. It was noted in Classrooms 1 eight (8) feet of fin tube radiation is now on an interior wall due to the 2001 classroom addition project. The control valve serving that fin tube

has failed open and the maintenance staff manually adjusts that balancing valve on that fin tube based on complaints from the teacher whose desk is in front of the heater.

**Figure 7: Balancing Valve used for manual control**

It is recommended existing building commissioning (e.g. Retro-commissioning) on the HVAC system be performed at the school to identify system components that are in need of repair or replacement and rebalance the HVAC system to assure it serves the current need of the spaces it serves. This recommendation is based on a 2009 Research project by Lawrence Berkley National Lab that found virtually all retro commission projects were cost-effective with average payback of less than 2 years. GDS has professional relationships with several local commissioning providers and can provide their contact information if the school board wishes to include them in an RFP for retro-commissioning the Washington School.

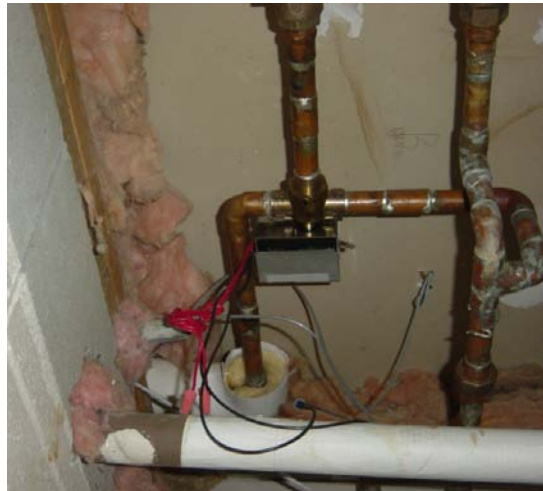
**Figure 8: Failed control valve in hallway ceiling.**

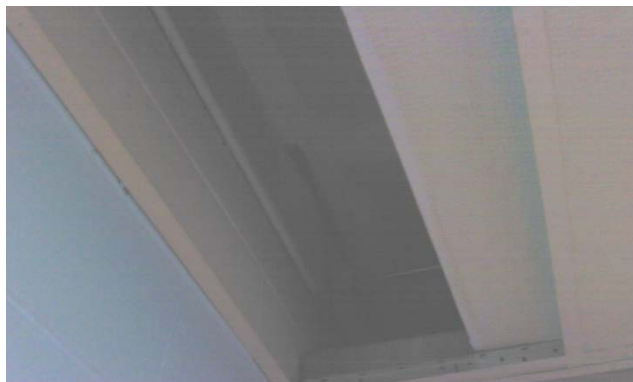
During the site visit it was learned the eave end of the school suffered from ice dams. To combat the ice dams approximately 300 feet of heat cabling operates on the front side of the school, which faces North, when the snow is on the roof. Ice dams are typically caused by hot air escaping the building at the wall to roof construction joint causing the snow on the roof to melt and freeze at the eave. Investigation of the exterior wall in the kitchen, which has the heat cabling on the eave, found cold air movement. Figures 9 and 10 below show the IR image and picture of this location.

**Figure 10:** Picture of same kitchen exterior wall

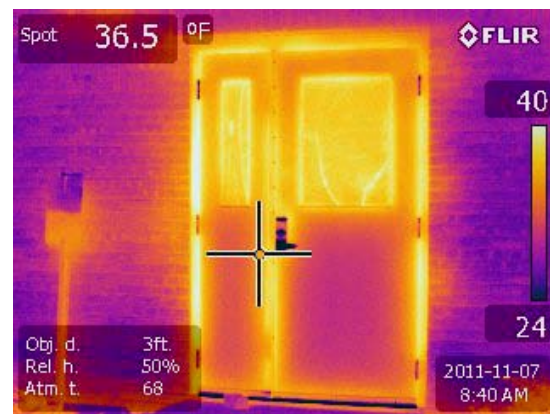
IR imaging of the exterior doors at the Washington Elementary School found the  
**GDS Associates, Inc.**

**Figure 11:** IR image of Multipurpose Room exterior door

majority of exterior doors in need of new door seals and sweeps, see Figures 11 and 12, below. GDS recommend replacing the door seals and door sweeps on all exterior doors. GDS counted 13 failed door seal and sweeps during the site visit. Based on previous door sealing projects GDS estimates the current average leakage rate can be reduced by 3 CFM per exterior door by installing new door seals and door sweeps. Based on recent contractor pricing on similar projects GDS estimates the cost to install new door seals and sweeps at \$75 per door.

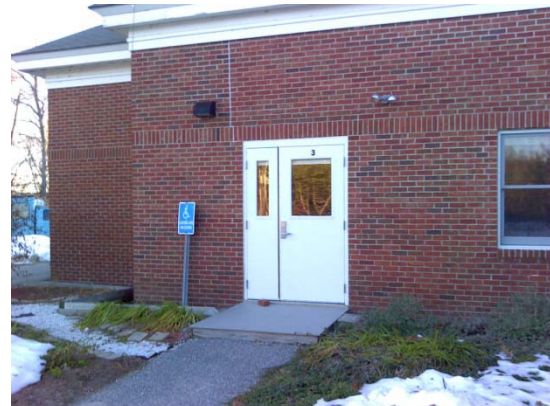
**Figure 12:** Picture of Multipurpose Room exterior door

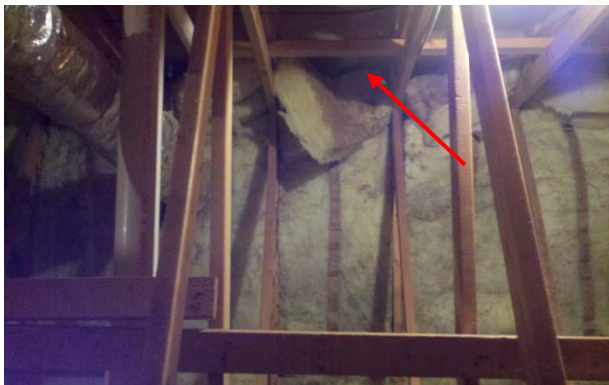
Inspection of the accessible portion of the attic spaces above the school found some fiberglass batt insulation in need of repair and what appears to be inadequate air sealing of all penetrations. This includes the fiberglass insulation in both the ceiling and in the kneewall that separates the mechanical room on the mezzanine from the attic. We recommend air sealing all accessible penetrations, repairing the batt insulation, and ideally adding additional insulation in the attic. The air sealing of penetrations in the ceiling should occur **prior** to repairing or adding additional insulation. Additional cellulose insulation can be blown in directly over the current fiberglass batts. Additional inches of blown in cellulose may be required in spots where fiberglass batts are missing. Typically air sealing, repairing insulation and adding additional insulation can be performed by maintenance staff or volunteers and provide an immediate payback.

**Figure 13: Kneewall insulation in need of repair**

### **1) Repair and replace damaged attic insulation and air seal penetrations:**

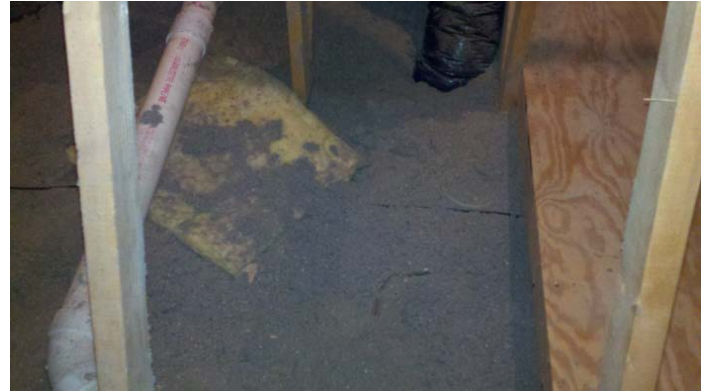
**Figure 14: Cellulose insulation over original portion of school.**

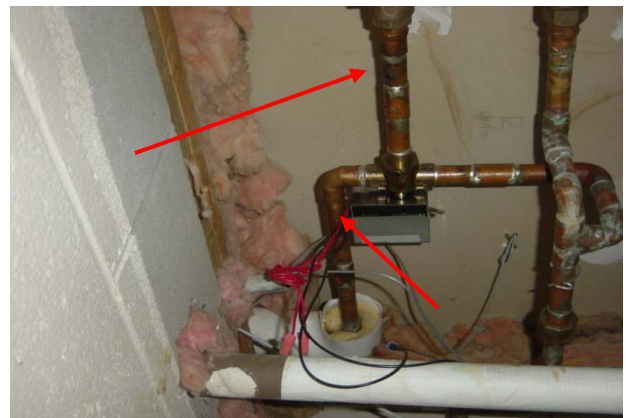
Inspection of the hot water heating system identified several areas where pipe insulation was lacking. We recommend adding proper insulation to all exposed heating piping. This includes the exposed piping in above the acoustical ceiling but below the attic. Typically adding pipe insulation can be performed by maintenance staff or volunteers and provide an quick payback.

**Figure 15: Lacking pipe insulation above corridor**

### **2) Repair and replace hot water pipe insulation:**

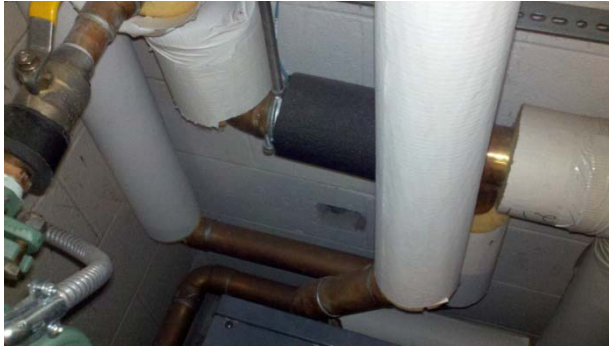
Figure 16: Lacking pipe insulation behind boilers
