# Decision Grade Audit Report

Town of Washington, NH

Police Station

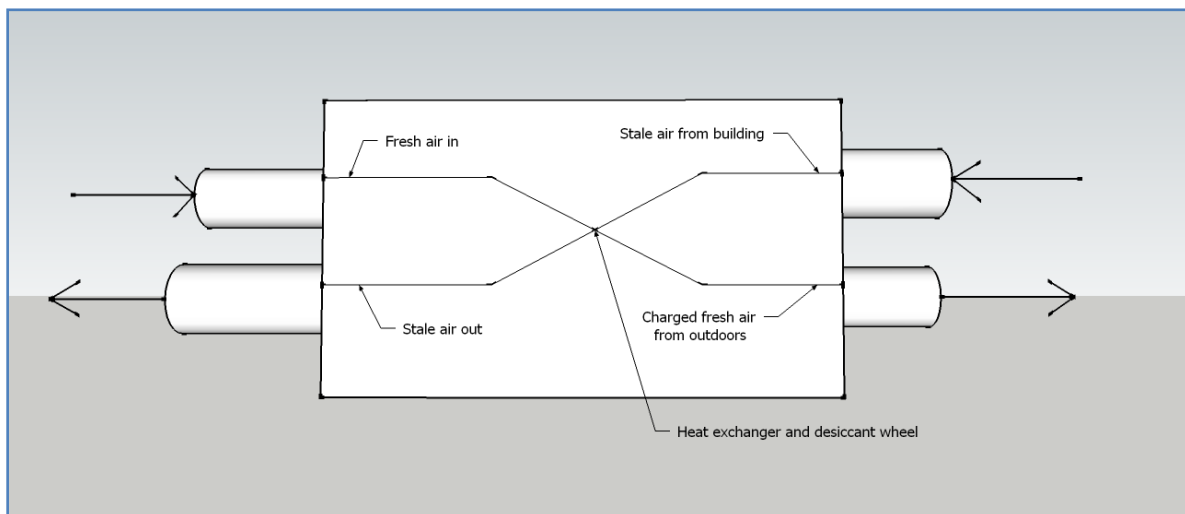
Figure 11

The most energy efficient way to provide fresh air in this case would be with an energy recovery ventilator (ERV). An ERV functions by removing a percentage of the stale air from the return plenum, and then introduces charged, fresh air to the return plenum right before the air-handler. In the winter, warm/stale air being removed from the building will charge the incoming fresh air with a heat exchanger located inside the ERV. Conversely, in the summer months the exhausted cool/stale air from the interior will cool down the hot/humid air from the exterior before entering the air-handler. An ERV has a desiccant wheel as well. This allows for the transfer of moisture. In the winter months, moisture in the exhaust air will be transferred to the incoming dry air to help maintain occupancy comfort. In the summer, dry/conditioned air from the interior will remove, at least a portion of, the moisture from the humid incoming air. See Figure 10.
